REPORT NUMBER CFR1901142

AD HOC FIRE RESISTANCE TEST TO THE GENERAL PRINCIPLES OF BS 476: PART 21: 1987

A timber joist ceiling sample with three voids and one downlight fitted into each of the voids A, B and C.

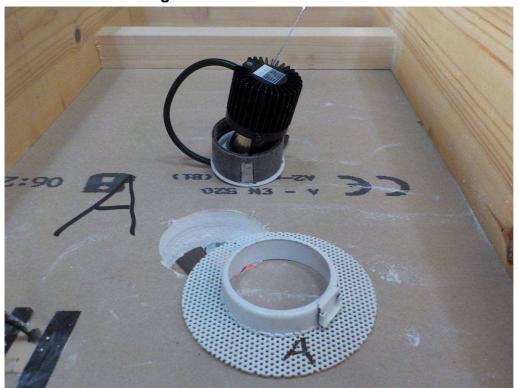
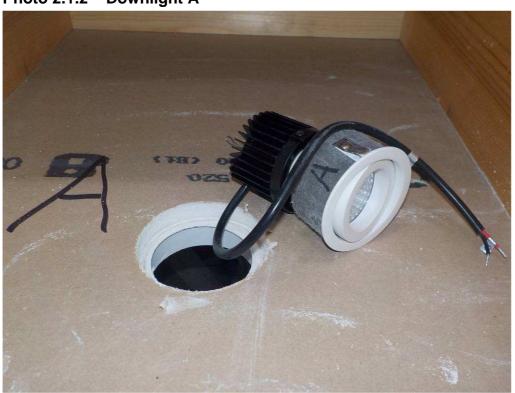
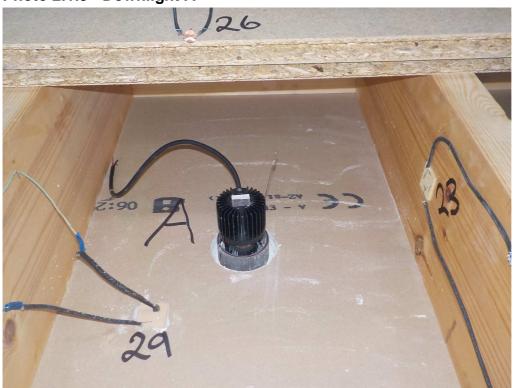
Appendix 2.1 Pre-test photos Photo 2.1.1 – Downlight A

Photo 2.1.2 – Downlight A

Photo 2.1.3 - Downlight A

Item	Component	Information
4	Downlight A	
	Supplier:	Darklight Design
	Name:	Eiger Adjustable LED tilt downlight
	Description:	An integrated LED downlight with die cast alloy
		heatsink painted black, an integral LED above a
		diiffusing lens and reflector. A cast alloy reflector ring
		is attached to the heatsink with two steel legs and
		countersunk screws. A cast alloy tilt ring with riveted
		spring clips is attached to the reflector ring with
		countersunk screws. A 61 OD x 30 high, 0.6 mm thick
		steel friction fit sleeve mounts over the tilt ring with
		self adhesive internal and external graphite based
		intumescent.
		The perforated steel plaster ring has a 21 high boss
		that retains the downlight spring clips and is affixed to the plasterboard with a gypsum based compound.
		The downlight is fitted central to the void.
	Hole size (Ø):	78
	Weight (g)	288
	Overall size:	
	Downlight (Ø x h):	69 x 92
	Plaster ring (Ø x h):	125 x 21

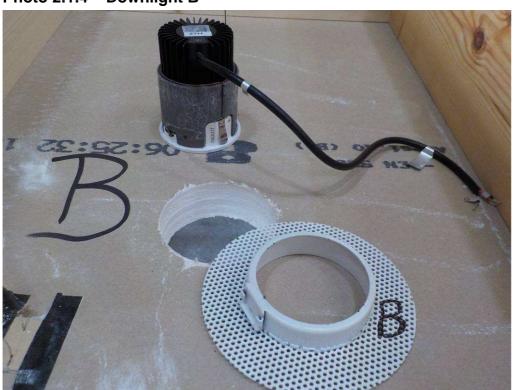
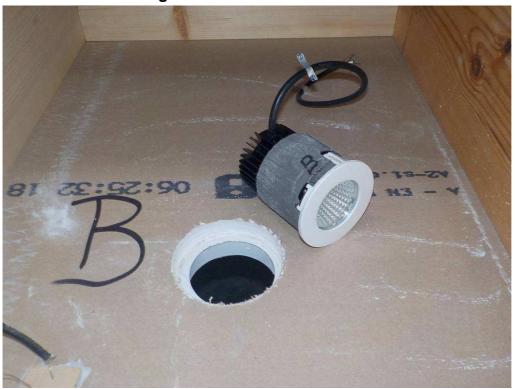
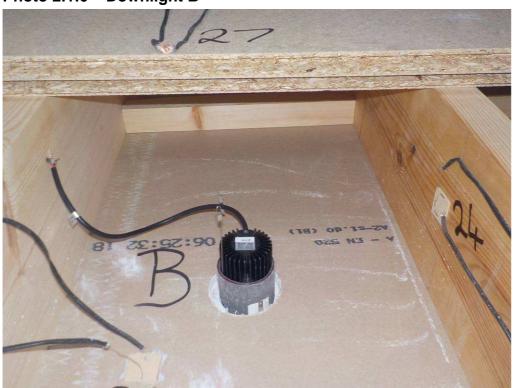
Photo 2.1.4 – Downlight B

Photo 2.1.5 – Downlight B

Photo 2.1.6 – Downlight B

Intumescent ring (h x t):	Internal 7 x 1.5, External 30 x 1.5
5	Downlight B	
	Supplier:	Darklight Design
	Name:	Eiger LED fixed downlight
	Description:	An integrated LED downlight with die cast alloy
		heatsink painted black, an integral LED above a
		diiffusing lens and reflector. A cast alloy reflector ring,
		with 2No. riveted spring clips, is attached to the
		heatsink with two steel legs and countersunk screws.
		A 61 OD x 53 high, 0.6 mm thick steel friction fit sleeve mounts over the reflector ring with self
		adhesive internal and external graphite based
		intumescent.
		The perforated steel plaster ring has a 21 high boss
		that retains the downlight spring clips and is affixed to
		the plasterboard with a gypsum based compound.
		The downlight is fitted central to the void.
	Hole size (Ø):	78
	Weight (g)	320
	Overall size:	
	Downlight (Ø x h):	69 x 86
	Plaster ring (Ø x h):	125 x 21
	Intumescent ring (h x t):	Internal 7 x 1.5, External 53 x 1.5

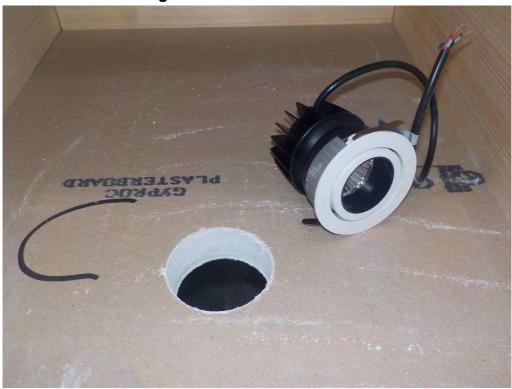
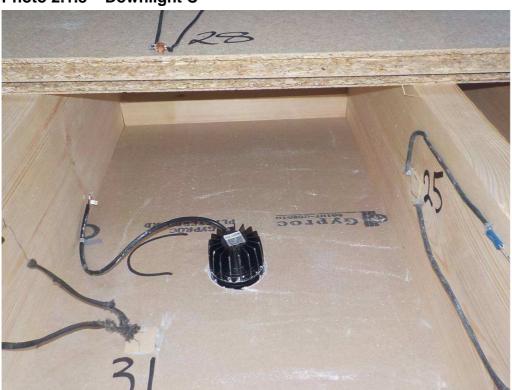
Photo 2.1.7 – Downlight C

Photo 2.1.8 – Downlight C

Item	Component	Information
6	Downlight C	
	Supplier:	Darklight Design
	Name:	Atlas Adjustable LED tilt downlight
	Description:	An integrated LED downlight with die cast alloy
		heatsink painted black, an integral LED above a
		diiffusing lens and reflector. A plastic threaded bush
		connects the heatsink to a cast alloy reflector ring with
		riveted spring clips. A 63 OD x 25 high, 0.6 mm thick
		steel friction fit sleeve mounts over the reflector ring
		with self adhesive internal and external graphite based intumescent.
	Hole size (Ø):	The downlight is fitted central to the void.
	Weight (g)	195
	Overall size:	195
	Downlight (Ø x h):	76 x 83
	Intumescent disc (h x t):	Internal 10 x 1.5, External 19 x 1.5
	intumescent disc (n x t).	Internal 10 x 1.5, External 19 x 1.5

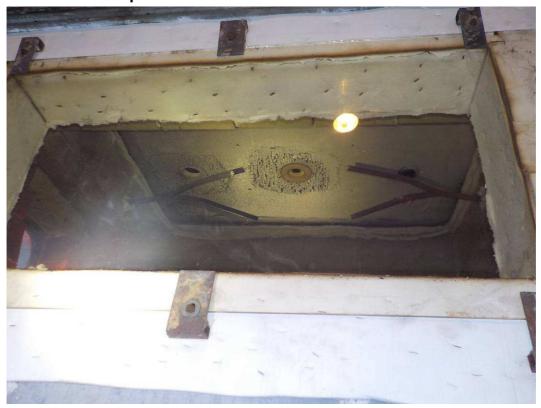
Photo 2.2.2 – Exposed face after 11 minutes.

TEST OBS	TEST OBSERVATIONS (E = Exposed face: U = Unexposed face)					
Time	Face	Observation				
(min:sec)						
00:00		Start of the test.				
05:20	Е	Lens of downlight A and C missing.				
06:37	Е	Internal components of C detached.				
08:01	Е	Internal components of A detached.				
09:40	Е	All components of A detached.				
15:48	Е	Bezel of downlight C softens and distorts.				
35:25	E	Section of outer layer of plasterboard detaches at void C with downlight C.				
48:49	Е	Outer plasterboard layer missing				
52:15	Е	Inner plasterboard layer cracks at various positions.				
53:03	Е	Flaming occurs at plasterboard joints.				
66:20	Е	Centre section of inner plasterboard layer detaches.				
67:00	Е	Test terminated.

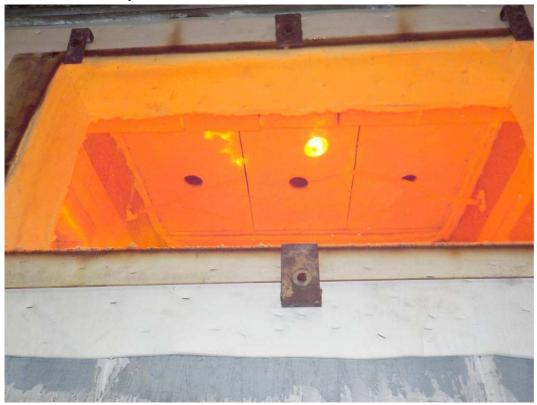
Photo 2.2.5 – Exposed face after 60 minutes.

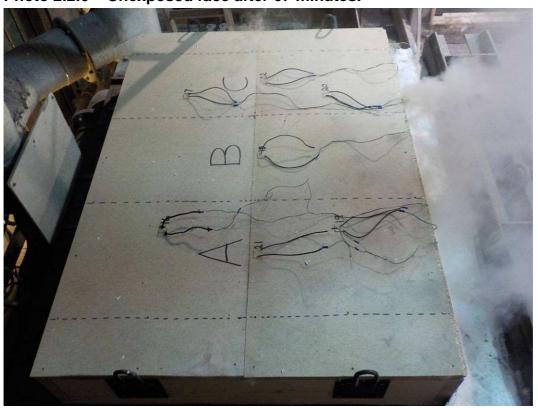
Photo 2.2.6 – Unexposed face after 67 minutes.
