C A M B R I D G E  
**FIRE RESEARCH**

**REPORT NUMBER**  
**CFR1901142**

**AD HOC FIRE RESISTANCE TEST TO THE  
GENERAL PRINCIPLES OF BS 476: PART 21: 1987**

A timber joist ceiling sample with three voids and one downlight fitted into each of the voids A, B and C.

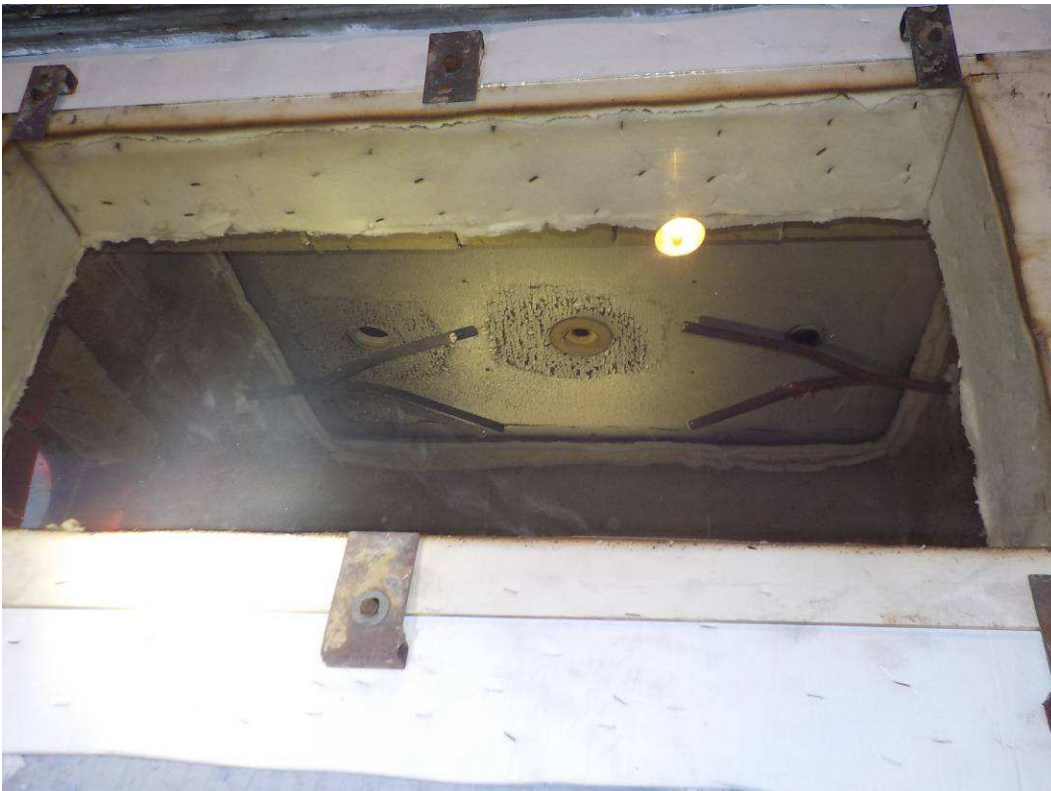
Photo 2.2.2 – Exposed face after 11 minutes.

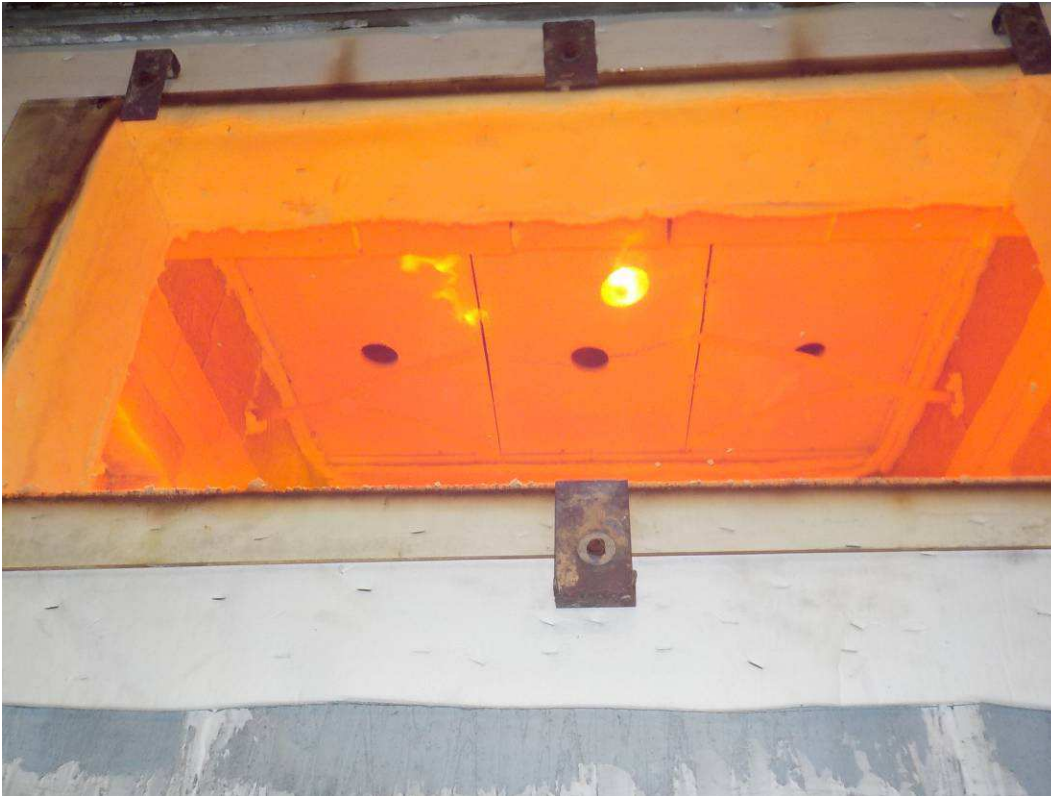
**Photo 2.2.5 – Exposed face after 60 minutes.**
